26 August 2020

**Subject: Gas Monitoring and Control System Restoration Completion Letter –
Response to Additional Comments from DTSC
Genentech Building 48
645 East Grand Avenue
South San Francisco, California 94080
Langan Project No. 731677307**

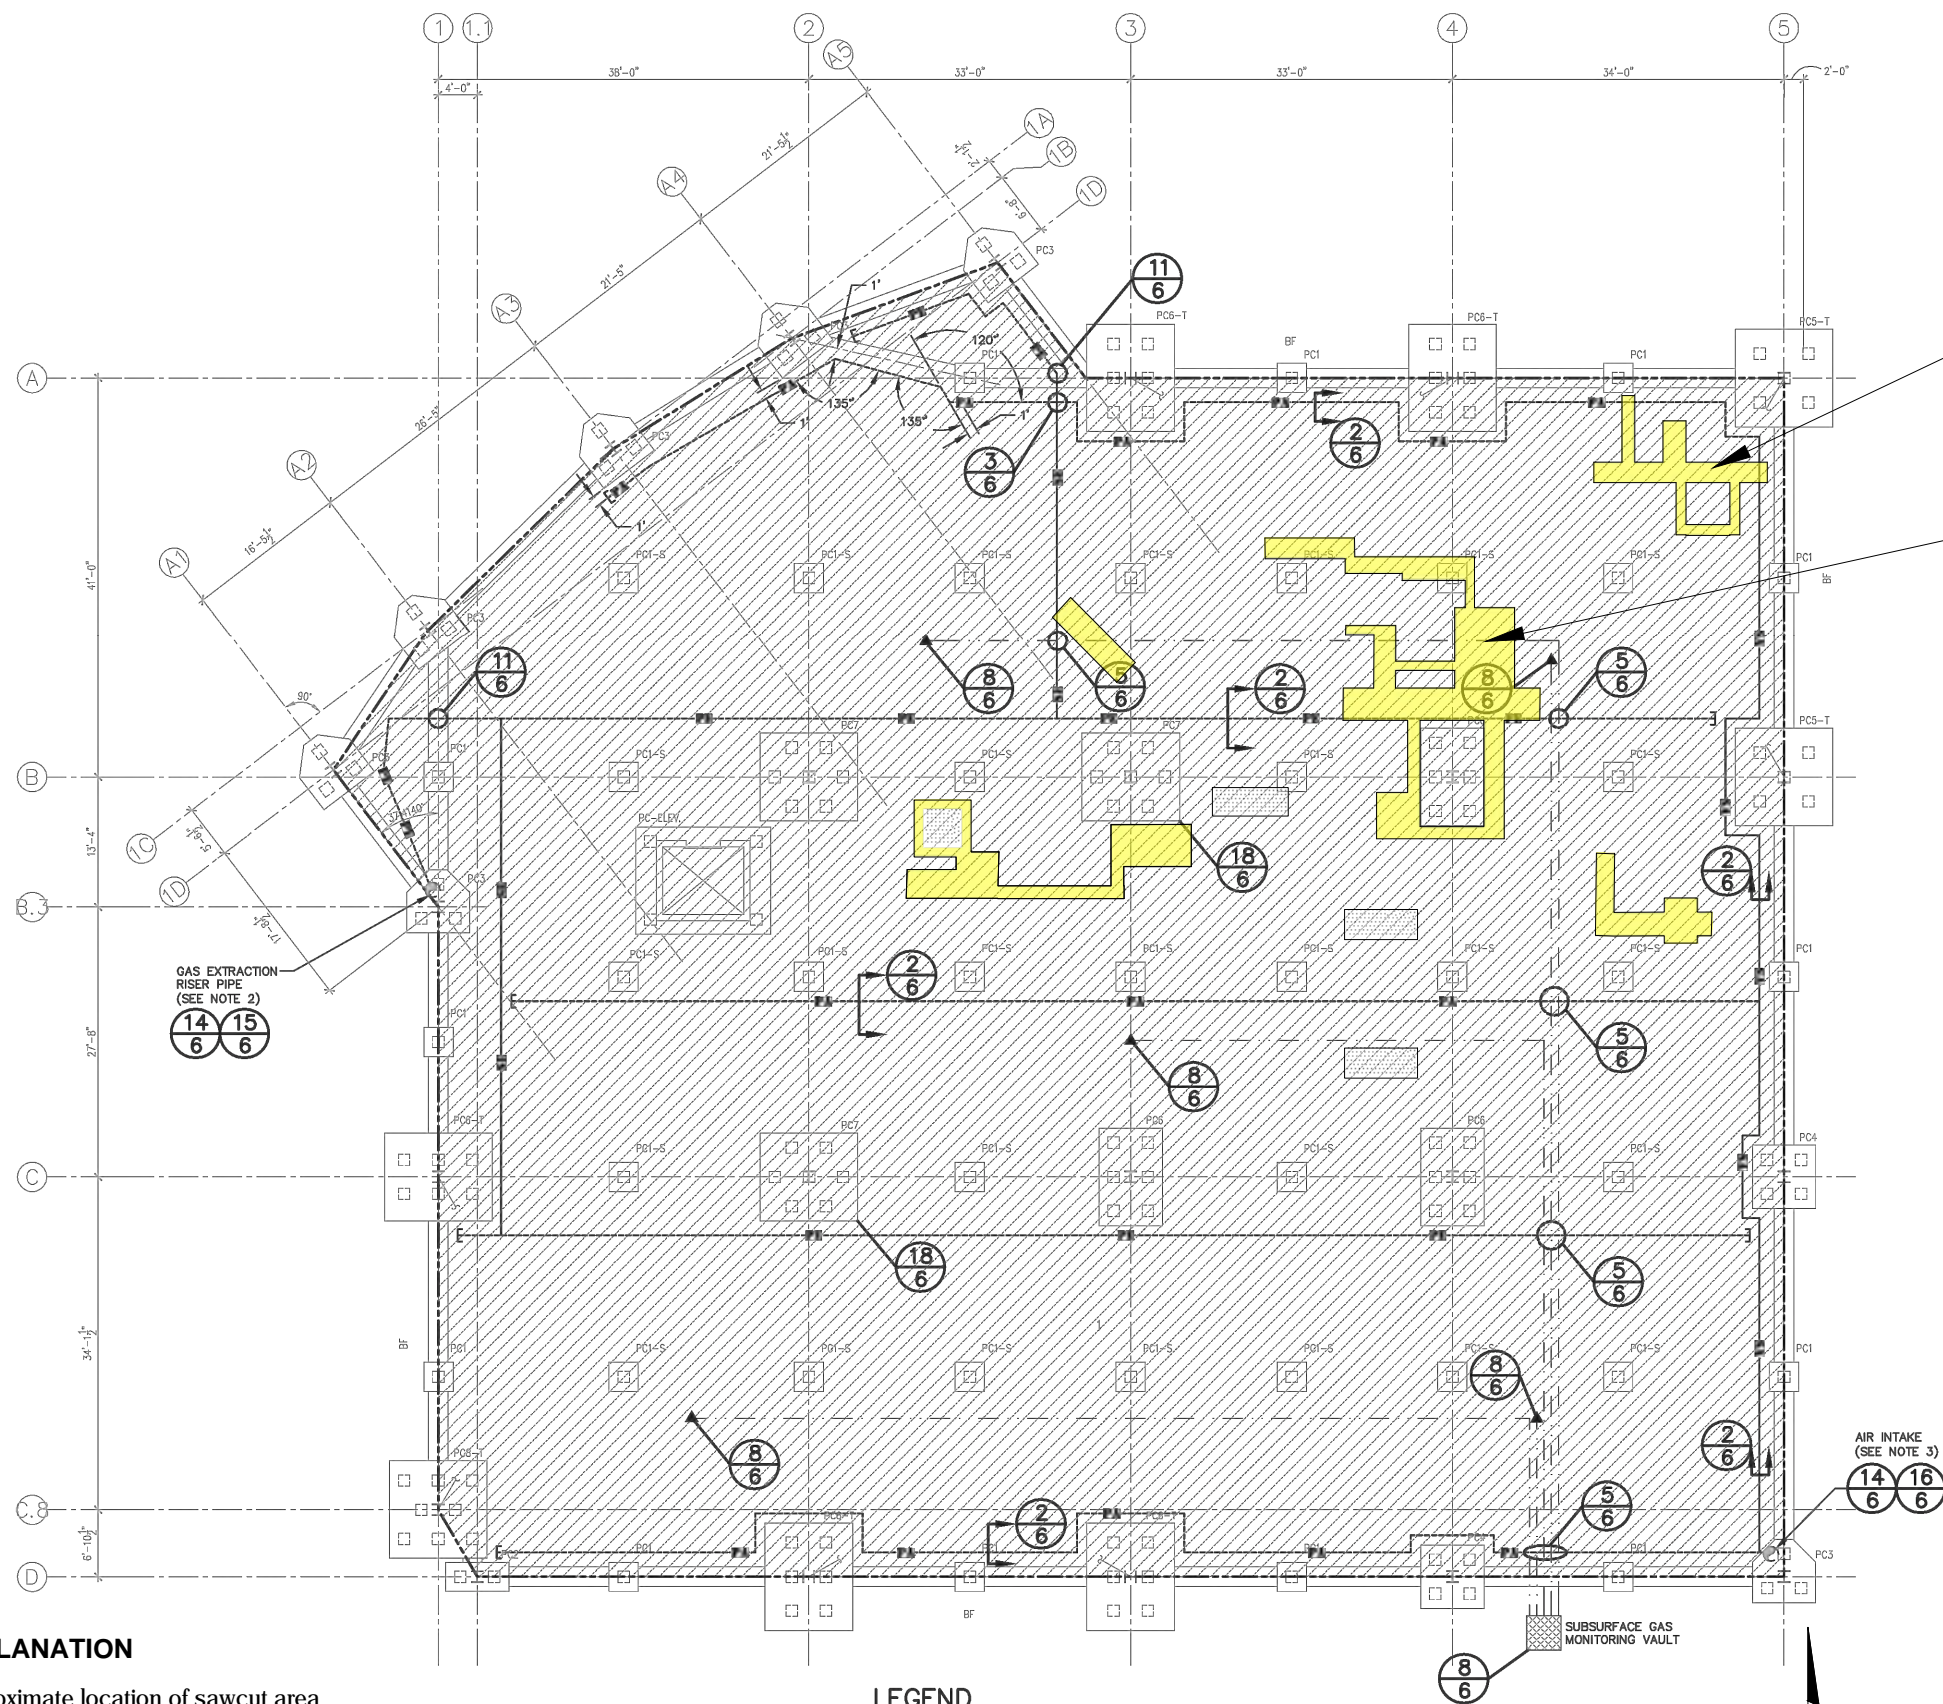
SEE FIGURE 2 FOR
TYPICAL GMCS
GEOMEMBRANE
RESTORATION DETAIL

SEE FIGURE 3 FOR
TYPICAL GMCS PIPE
RESTORATION DETAIL

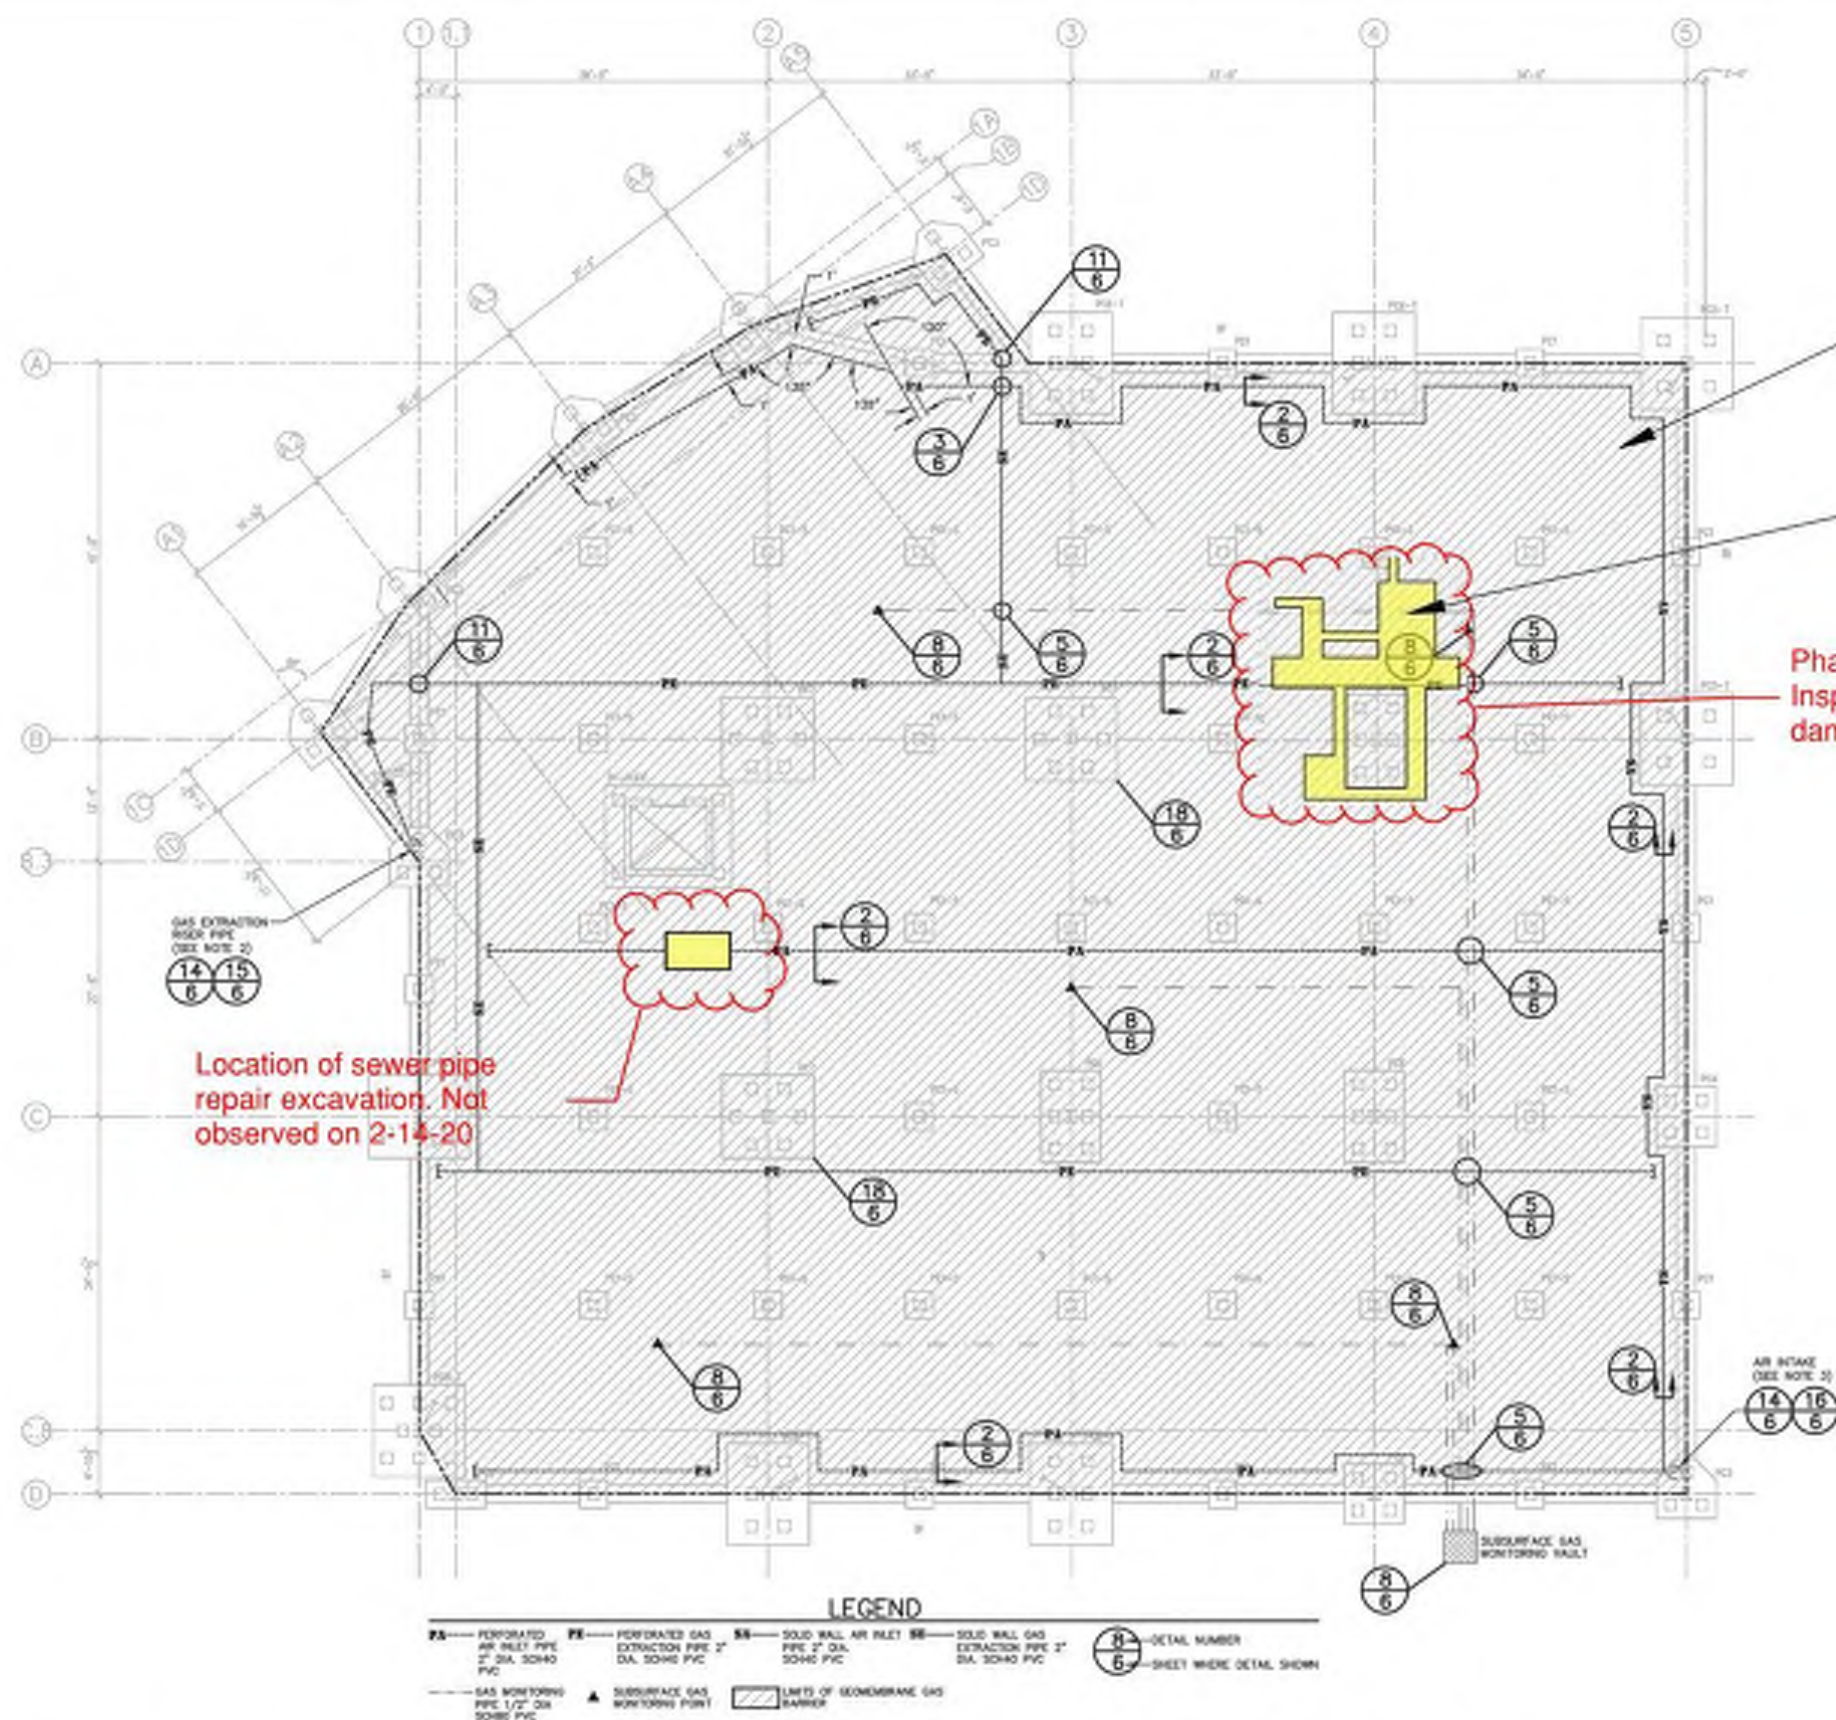
1030 Daniel Wood observes concrete cut during Phase 2 Saw Cutting. Location of cutting is ~~in middle of basement~~, adjacent to loading dock entrance. White 2" PVC gas extraction pipe cut during saw cutting to be repaired the following week prior to GMCS repair.

Photograph 4: View of Phase 2 Saw Cutting area and cut 2" PVC gas extraction pipe (facing west).

SEE FIGURE 2 FOR
TYPICAL GMCS
GEOMEMBRANE
RESTORATION DETAIL

SEE FIGURE 3 FOR
TYPICAL GMCS PIPE
RESTORATION DETAIL
